⁵⁰ ⁷²
November 1967 ARS 41-138

ANCHORING AUTOMOBILE BODIES FOR STREAMBANK PROTECTION¹

Bruce J. Blanchard²

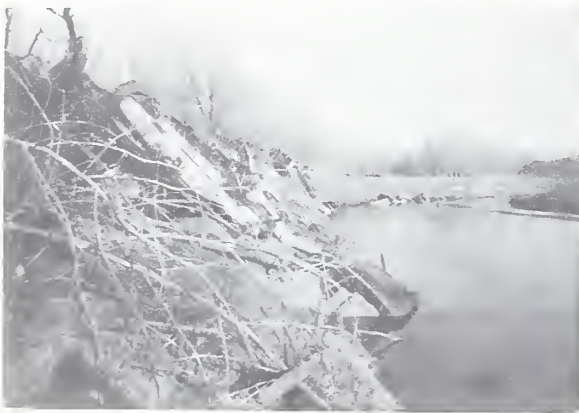
The most striking observation made over the entire survey area was the failures due to lack of some means of locking the bodies together. Figure 1 shows individual bodies anchored by cables to trees at the top of the bank. Shifting of individual bodies exposed the bank in spots and erosion undermined the trees used as anchors, thus destroying the effectiveness of the entire installation. Only one installation was found that had apparently been successful without anchorage.

Figure 1.--Bank protection failure due to inadequate anchorage.

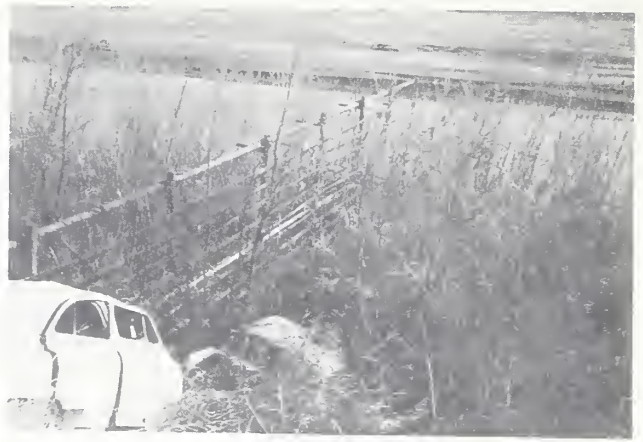
Some installations made by oil companies were held in place by wood or steel jetties with the bodies used to protect the intervening areas. Costs are obviously higher for this type of construction, but no failures were observed. The intervening areas between jetties were not completely protected in some cases where velocities were low. One such installation is shown in figure 2. Willows were planted along this bank when the jetties were constructed.

Figure 2.--Partial protection between jetties proves successful when the area is not under direct attack.

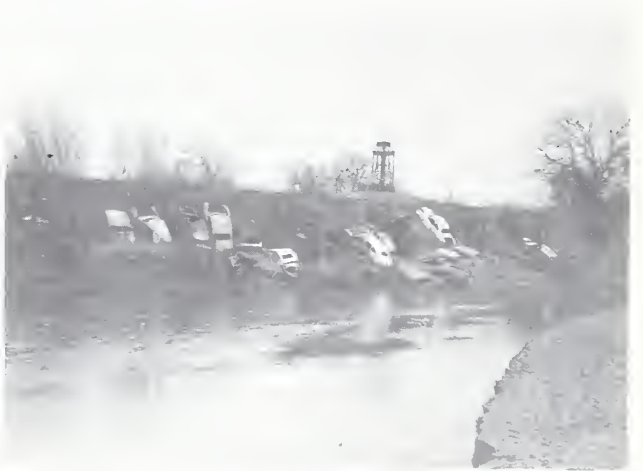
Figure 3.--Complete protection between jetties by automobile bodies.

Another installation showing complete cover of the banks is illustrated in figure 3. This installation had been in place for 17 years and had not required extensive repair or alteration. At half-bankfull stages, the highest velocities approach this bank at approximately 45°.

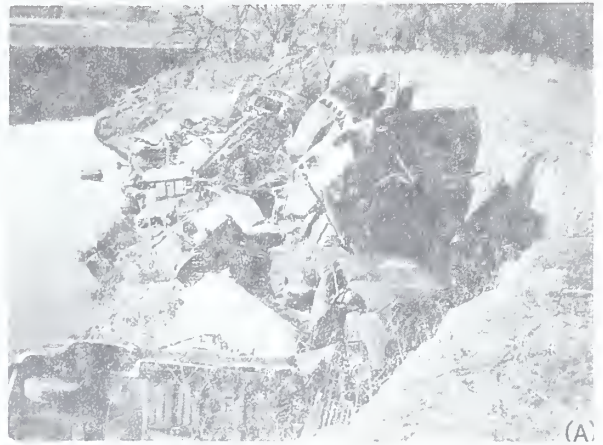
Figure 6.--(A) An example of poorly arranged bank protection, (B) Displaced automobile bodies diverting flow in the channel.

Unanchored bodies not only failed to provide the intended protection, but posed a severe hazard to control of the channel. Figure 6, A and B, was taken at the same location to illustrate how damaging random dumping of automobile bodies can be. The currents in figure 6, B, may cause radical change of direction of the channel at slightly higher flows than that shown in the photograph. Removal of these displaced bodies is both difficult and expensive after they have filled with sediment.

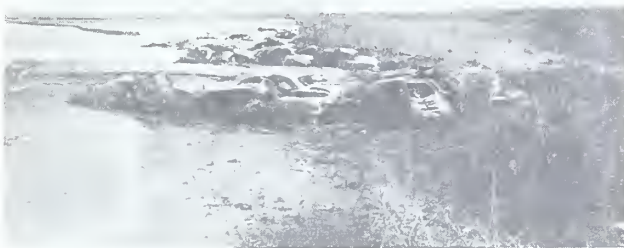
Figure 5.--Low-flow jetties constructed of well-anchored automobile bodies on the South Canadian River.

well where flow depth does not exceed 7 or 8 feet. These jetties are anchored to one piling located at each end of the arrangement of bodies by threading a cable lengthwise through the bodies.

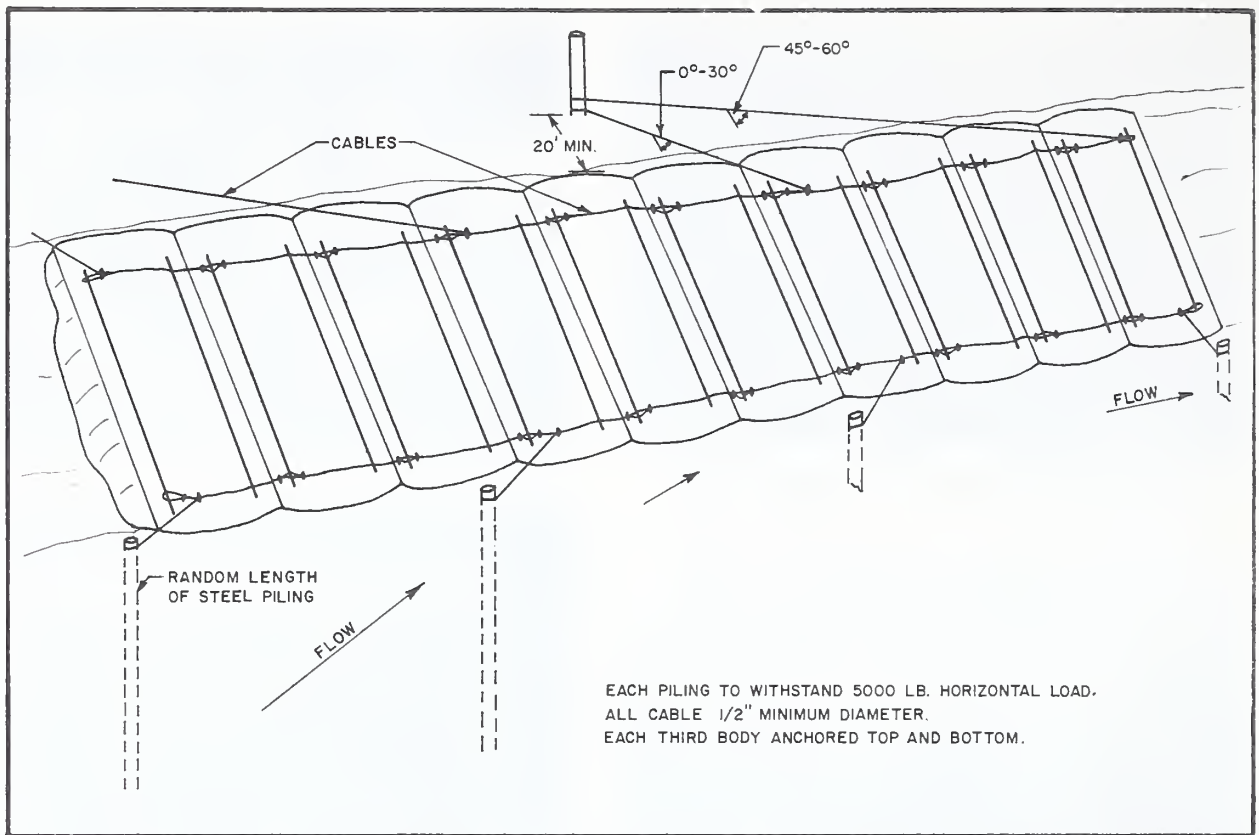
Figure 7.--Cable anchorage for automobile bodies.

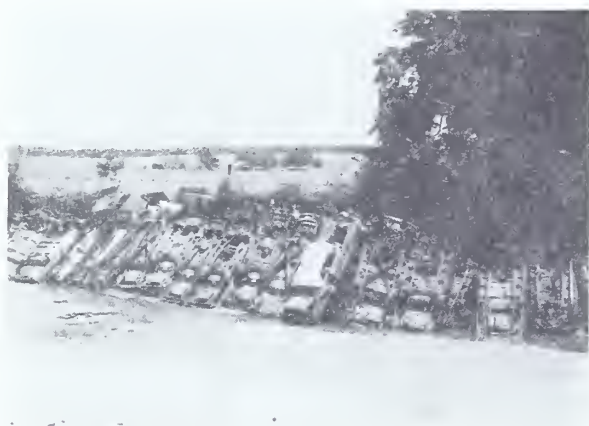
Figure 9.--Upstream end of bank protection placed on Winter Creek north of Alex, Okla.

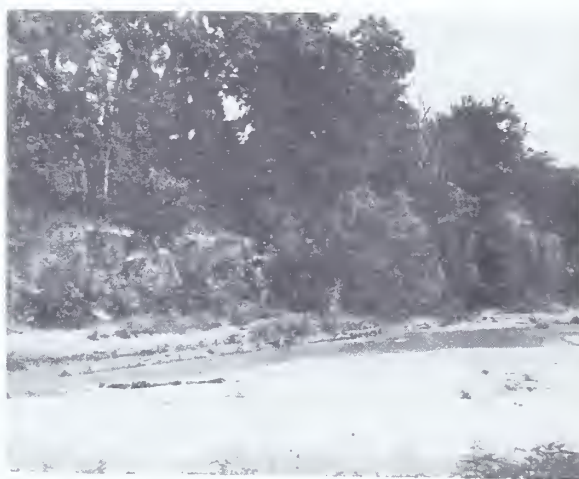
first flow. At the end of 3 years, the bodies are well screened from view (fig. 10). No maintenance cost has been necessary other than a periodic check of the cables.

Figure 10.--Downstream end of bank protection placed on Winter Creek north of Alex, Okla.

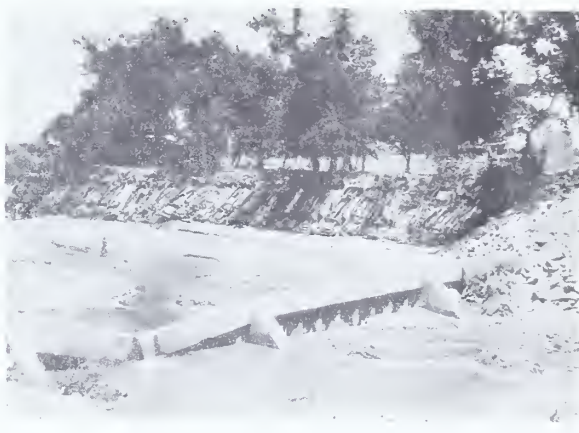
Figure 11.--Winter Creek installation after three years' growth of willows.
